CAFO FACILITY INSPECTION REPORT

INSPECTOR(S): Anthony D'Angelo (PG Environmental, LLC)

<u>8365130001</u> WDID NUMBER	<u>Martin Verhoeven</u> OWNER NAME	<u>Martin Verhoeven Dairy</u> FACILITY NAME
<u>CAG018001</u> NPDES NUMBER	<u>Ex. 6 Personal Privacy (PP)</u>	
<u>R8-2007-0001</u> RWQCB ORDER NO.	<u>Chino, CA 91710</u> OWNER CITY AND STATE	<u>Chino, CA 91710</u> FACILITY CITY AND STATE
<u>03/08/2013</u> SCHEDULED INSPECTION DATE	<u>Martin Verhoeven</u> OWNER CONTACT	<u>Martin Verhoeven</u> FACILITY CONTACT
<u>03/08/2013</u> ACTUAL INSPECTION DATE	<u>Ex. 6 Personal Privacy (PP)</u>	
<u>Unknown</u> RECEIVING WATER	<u>Ex. 6 Personal Privacy (PP)</u> OWNER PHONE NO.	<u>Ex. 6 Personal Privacy (PP)</u> FACILITY PHONE NO.
	<u>Ex. 6 Personal Privacy (PP)</u> FACILITY LATITUDE	<u>Ex. 6 Personal Privacy (PP)</u> FACILITY LONGITUDE

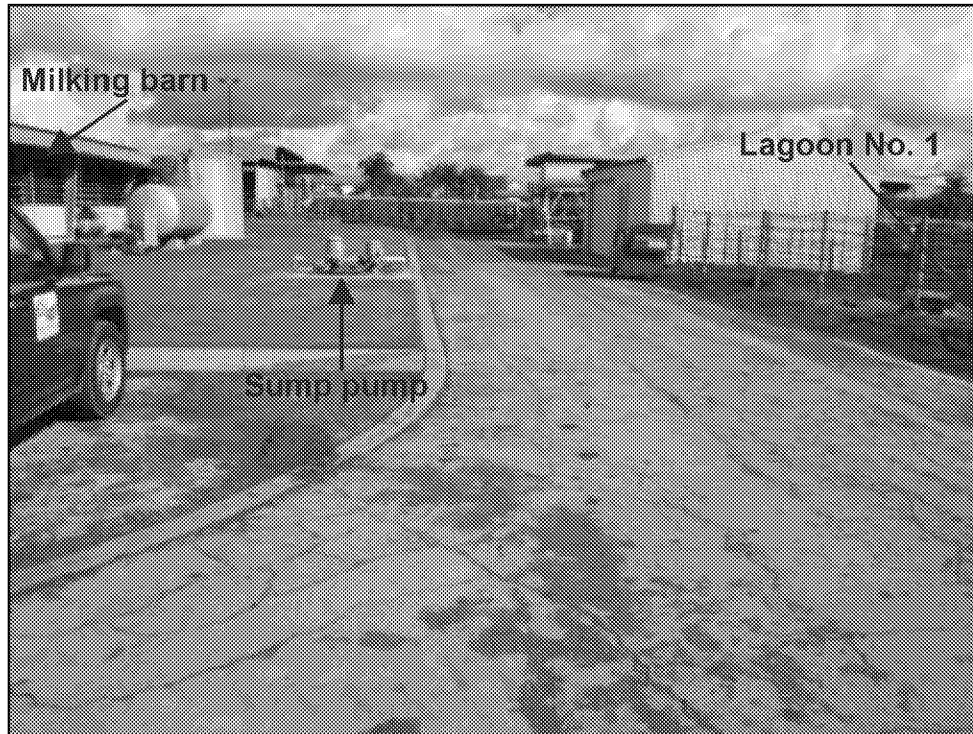
Photograph 2. View facing north of the sump pump located on the east side of the milking barn. The sump pump conveys process wastewater from the milking barn to lagoon Nos. 2 and 3.

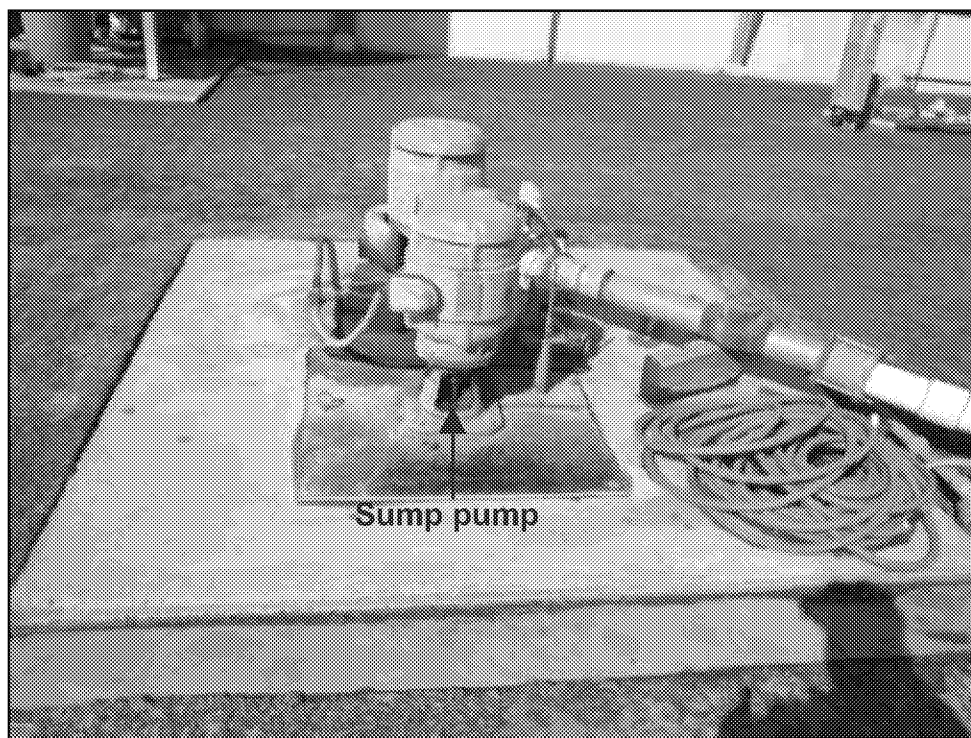
Photograph 3. Close-up view of the sump pump shown in Photograph 2.

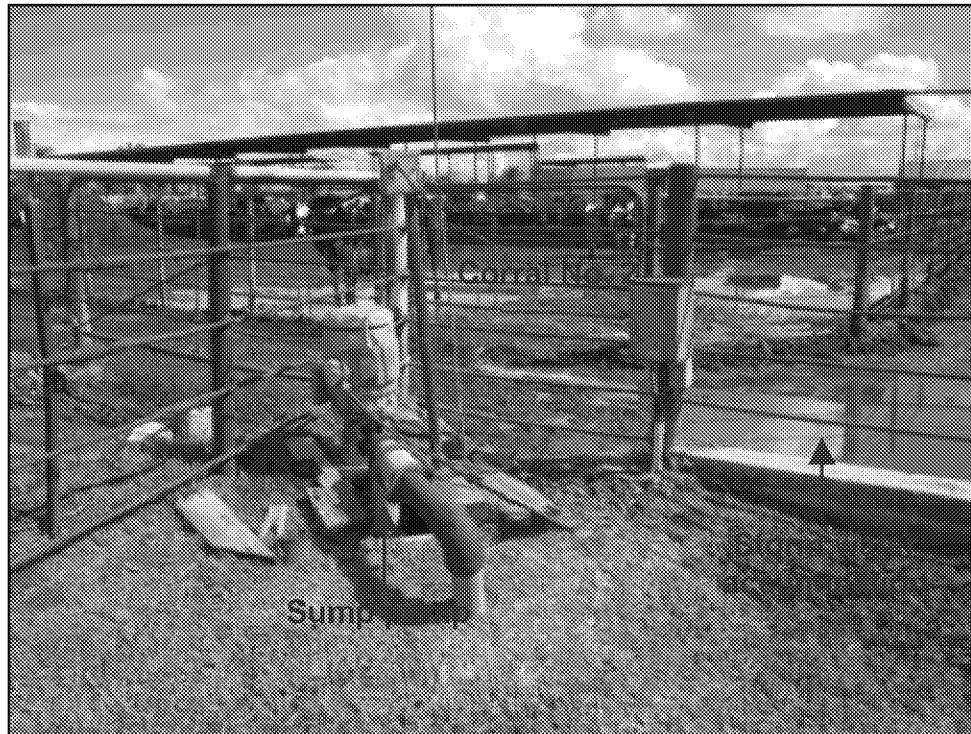
Photograph 4. View facing northeast of a sump pump located on the southwest corner of corral No. 2. Note the sump pump conveys storm water runoff from corral Nos. 1 and 2 to lagoon Nos. 2 and 3.

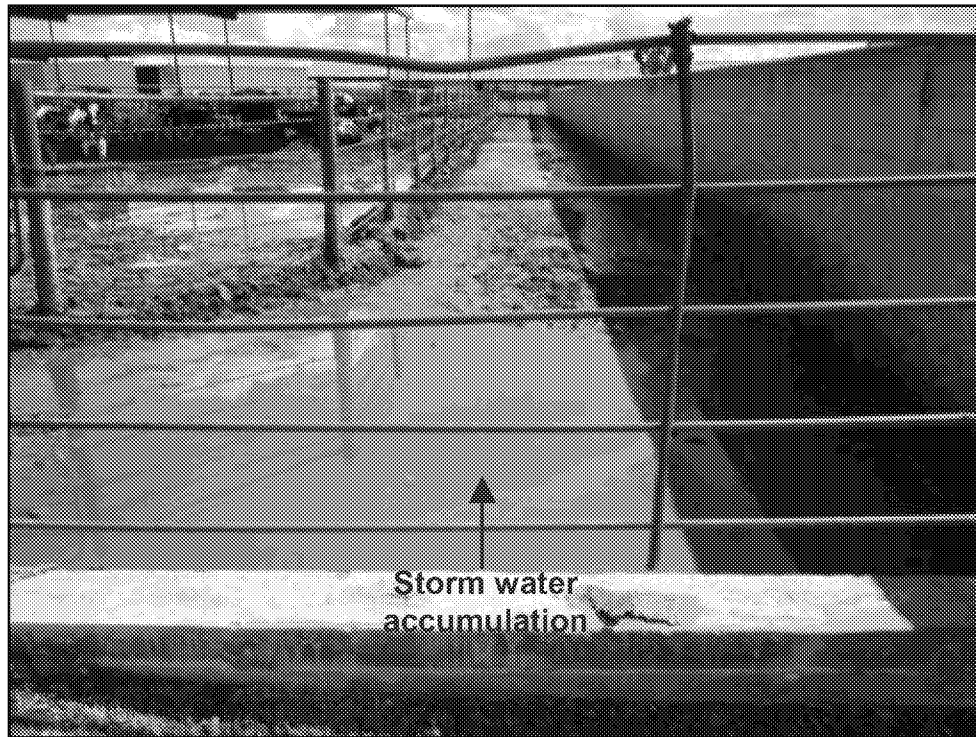
Photograph 5. View facing east from the sump pump shown in Photograph 4 of the accumulated storm water in the southwest corner of corral No. 2.

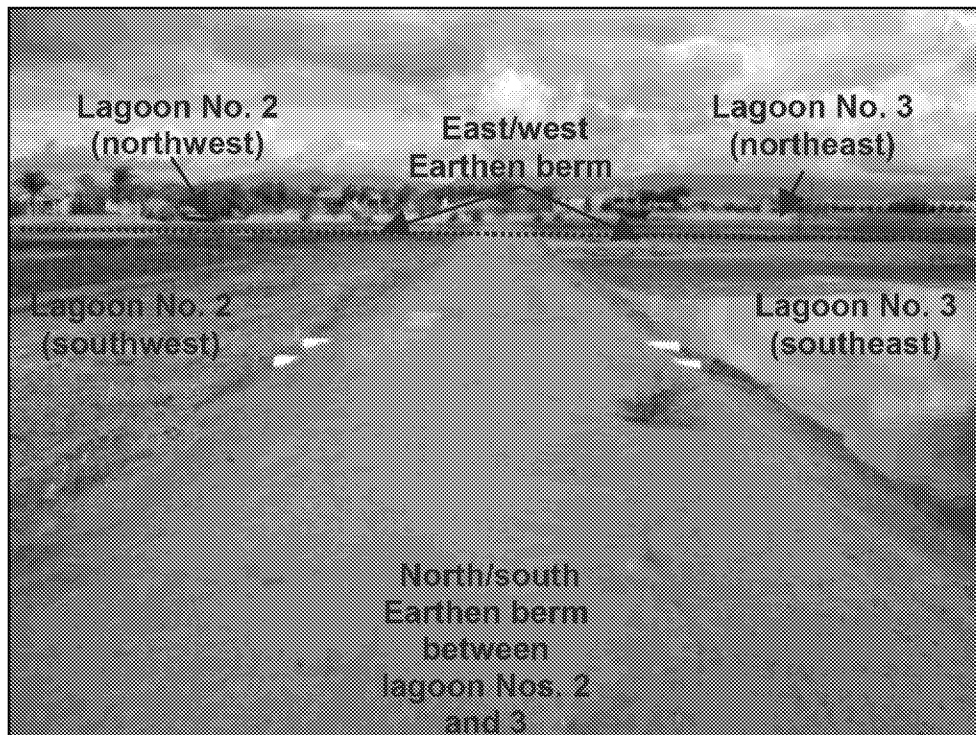
3. The EWMP was not fully implemented onsite and the containment structures had not been adequately maintained at the Facility at the time of the inspection, as required by Provisions VII.C.3.a and Provision VII.C.3.b of the Permit (refer to Photos 6, 11, 12, and 13).

2. The EWMP was not fully implemented onsite at the Facility or reflective of current Facility conditions as required by the Permit. Section I - 'Introduction' of the EWMP identifies three (3) lagoons at the Facility: Lagoon No. 1 in the southern portion of the Facility, and lagoon Nos. 2 and 3 in the eastern portion of the Facility. The inspector observed, during the inspection, that an east/west earthen berm had been constructed to divide lagoon Nos. 2 and 3 into four (4) separate lagoons (refer to Photos 6, 11, 12, and 13). Provision VII.C.3.b of the Permit states that "the discharger shall develop and fully implement an Engineered Waste Management Plan (EWMP) acceptable to the Executive Officer." Due to the separation of lagoon Nos. 2 and 3 into four (4) separate lagoons, the Discharger was not fully implementing the approved EWMP and Site Plan which only identified a total of three (3) containment structures not five (5) observed at the time of the inspection. The Discharger shall fully implement the EWMP as required by Provision VII.C.3.b of the Permit. This issue was identified in a previous inspection conducted on May 7, 2012.

Photograph 6. View facing north from the southern Facility perimeter of lagoon Nos. 2 and 3. Note the lagoons were divided into four (4) separate lagoons by an east/west earthen berm.

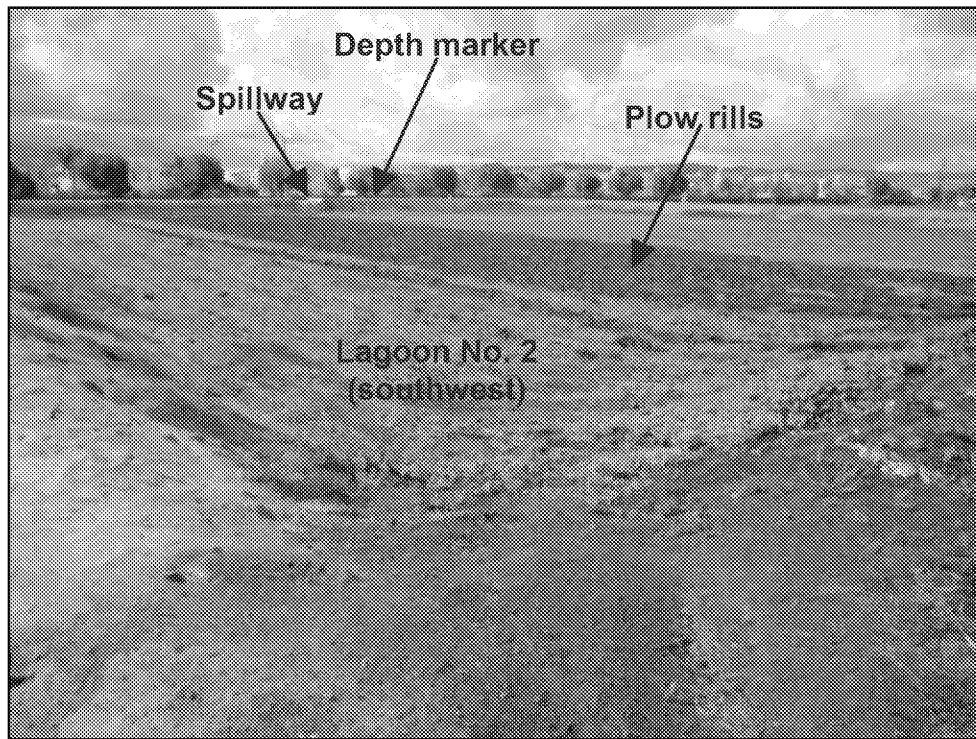
Photograph 7. View facing southwest from the intersection of the earthen berms separating the four (4) lagoons near the southwest lagoon portion of lagoon No. 2. Note the lagoon appeared to have been recently plowed and contained a depth marker and spillway on the south side.

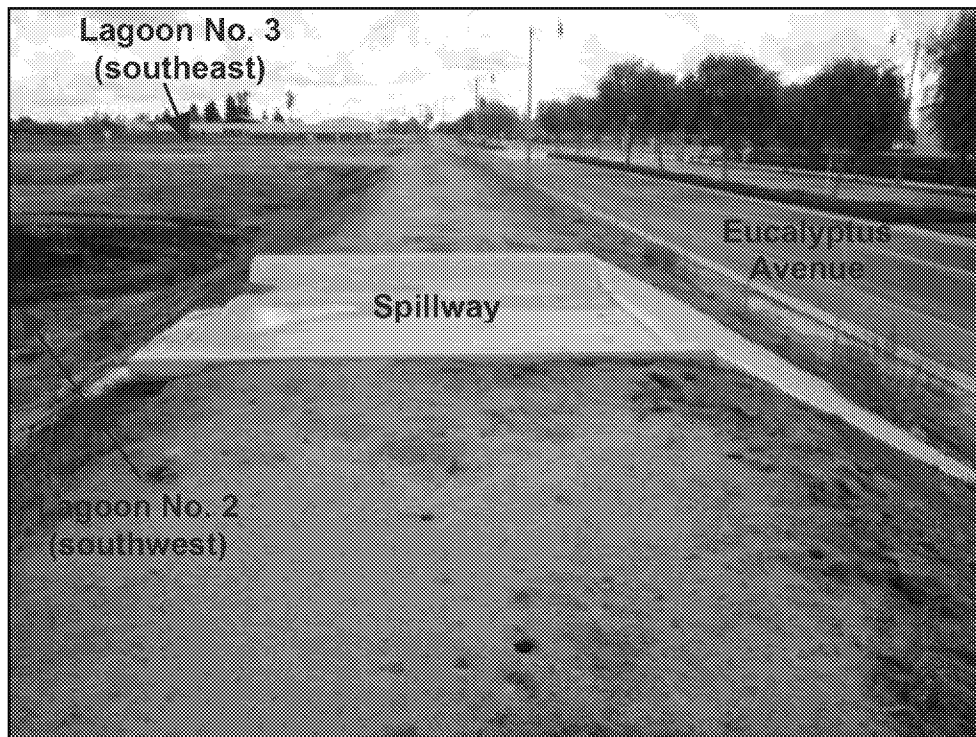
Photograph 8. View facing east of the concrete spillway located on the southern embankment of the southwest portion of lagoon No. 2, adjacent to Eucalyptus Avenue.

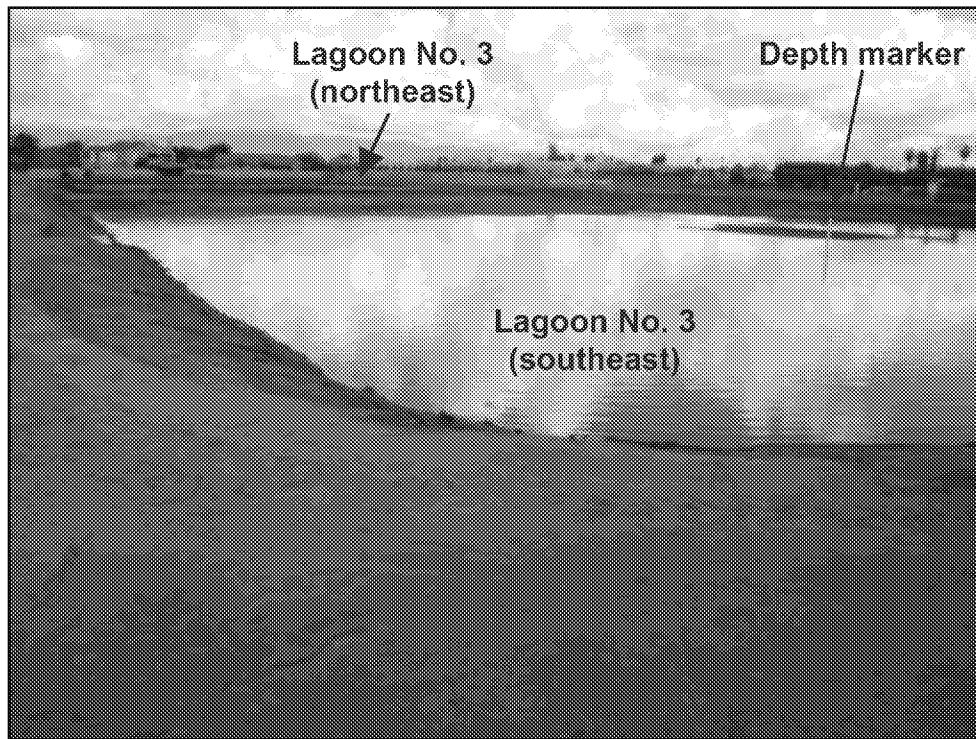
Photograph 9. View facing northeast from the southwest corner of the southeast portion of lagoon No. 3.

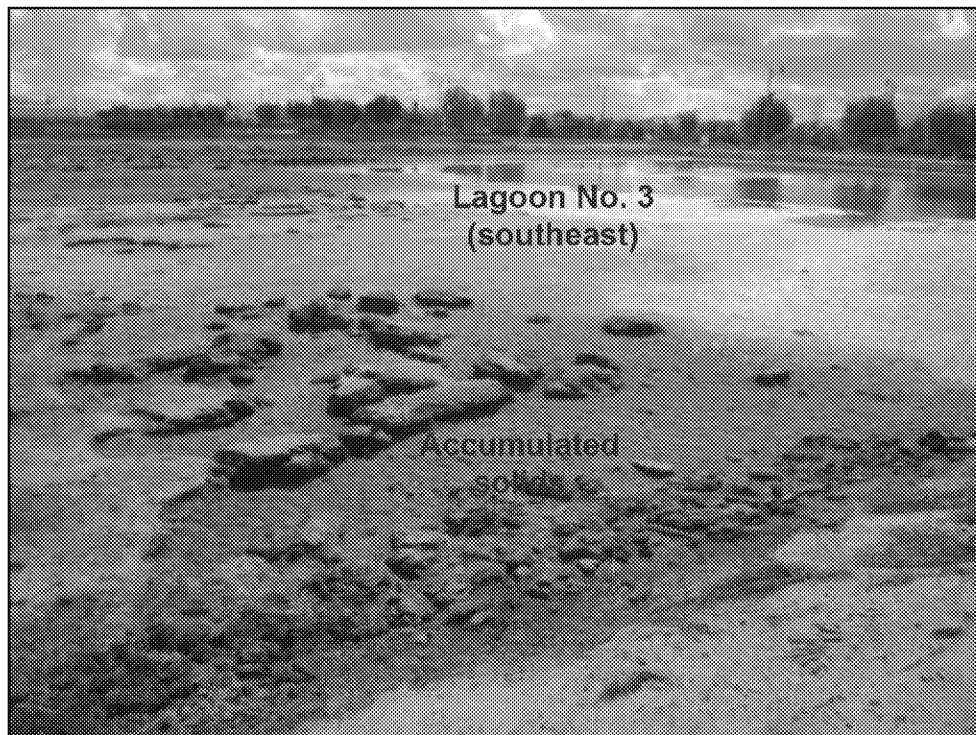
5. Accumulated manure solids were observed in lagoon Nos. 1, 2, and 3 in the southern and eastern portions of the Facility (refer to Photos 10, 11, 16, and 17). The Discharger must design and maintain all containment structures per the EWMP as required by Provision VII.C.3.a of the Permit.

3. The EWMP was not fully implemented onsite and the containment structures had not been adequately maintained at the Facility as required by the Permit. Section V - 'Operation and Maintenance' of the EWMP states that "lagoon solids shall be removed every summer to ensure full capacity in the lagoons before the start of the next winter season." Mr. Trino stated that the lagoons have not been cleaned in the nine (9) years he has worked at the Facility. The inspector observed that, accumulated solids were prevalent throughout the Facility's lagoons (refer to Photos 10, 11, 16, and 17). As a result of the accumulated solids in the lagoons, the Facility's containment structures capacity may be diminished. Provision VII.C.3.a of the Permit states that "the discharger shall design, construct, and maintain containment structures to retain all wastewater within the facility, including all process wastewater and all precipitation on, and drainage through, manured areas resulting from rainfall up to and including a 25-year, 24-hour rainfall event"; and Provision VII.C.3.b of the Permit states that "the discharger shall develop and fully implement an Engineered Waste Management Plan (EWMP) acceptable to the Executive Officer." The Discharger shall design and maintain all containment structures and fully implement the EWMP as required by Provisions VII.C.3.a and Provision VII.C.3.b of the Permit.

3. The inspector observed, during the inspection, accumulated manure solids in lagoon No. 1 in the southern portion of the Facility, as well as in the four (4) lagoons (identified in the EWMP and Site Plan as lagoon Nos. 2 and 3) (refer to Photos 10, 11, 16, and 17). This finding is addressed in Item No. 3 of the 'Engineered Waste Management Plan Review' section of this report.

Photograph 10. View facing southeast from the northwest corner of the southeast portion of lagoon No. 3. Note accumulated solids were observed in the lagoon.

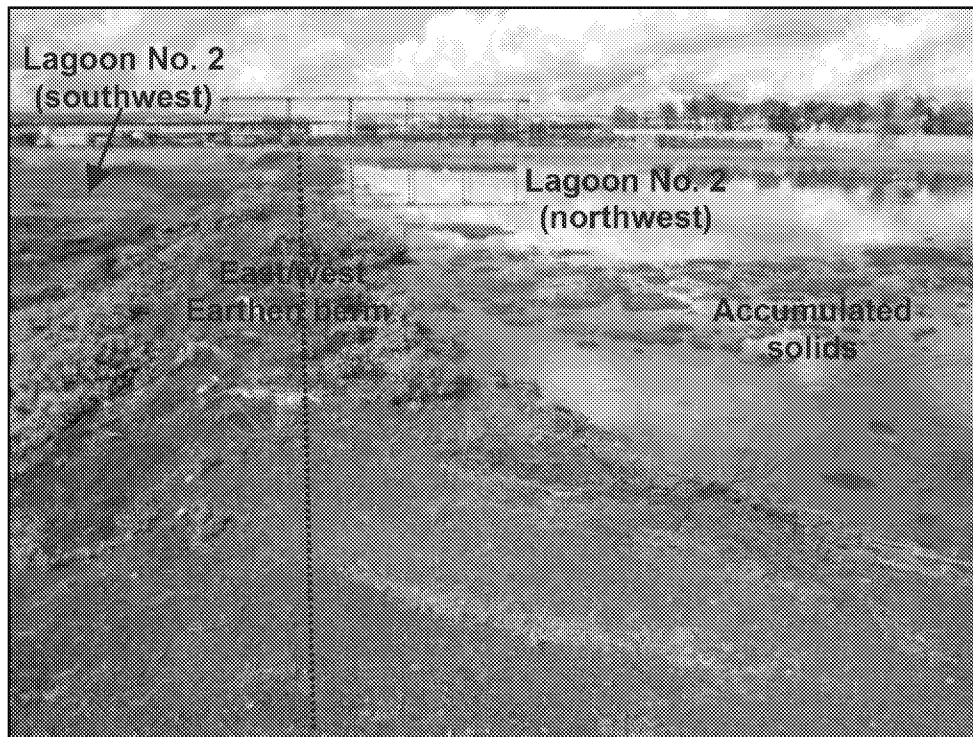
Photograph 11. View facing west of the east/west earthen berm that divides lagoon No. 2 into two (2) separate basins. Note the northwestern portion of lagoon No. 2 contained accumulated solids, and the lagoon did not contain a depth marker.

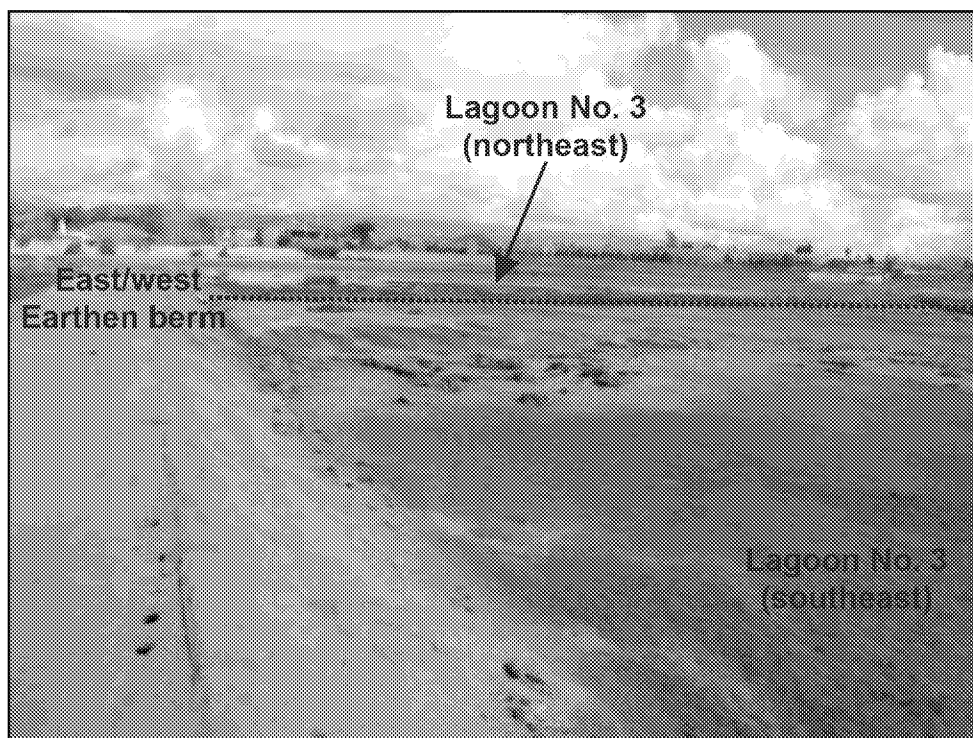
Photograph 12. View facing northeast of the east/west earthen berm that divides lagoon No. 3 into two (2) separate basins. The northeast portion of lagoon No. 3 did not contain a depth marker.

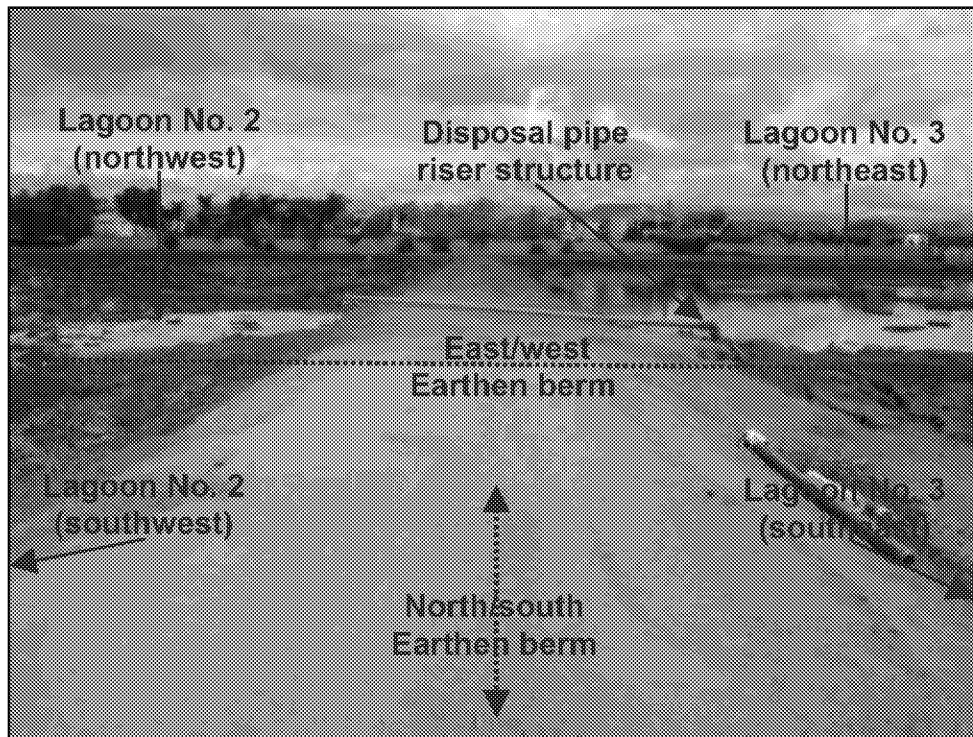
Photograph 13. View facing north of the disposal pipe riser structure located between the lagoons. Note process wastewater was actively flowing into the northwest portion of lagoon No. 2 at the time of the inspection.

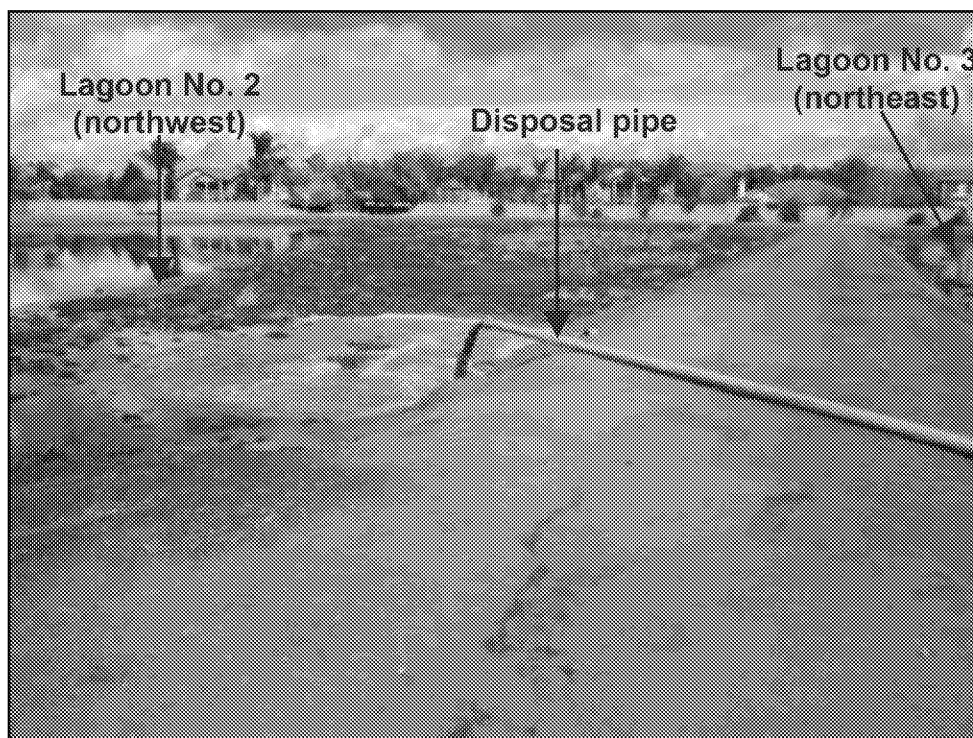
Photograph 14. Close-up view facing northwest of process wastewater actively flowing into the northwest portion of lagoon No. 2 from the disposal pipe.

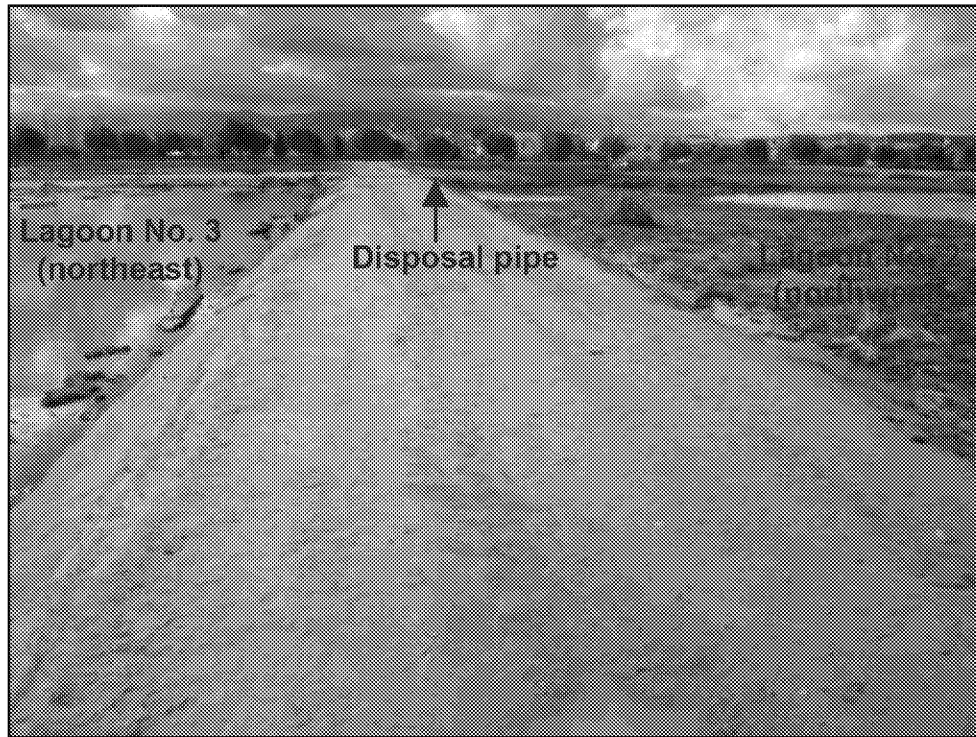
Photograph 15. View facing south from the northern Facility perimeter of the northern portions of lagoon Nos. 2 and 3.

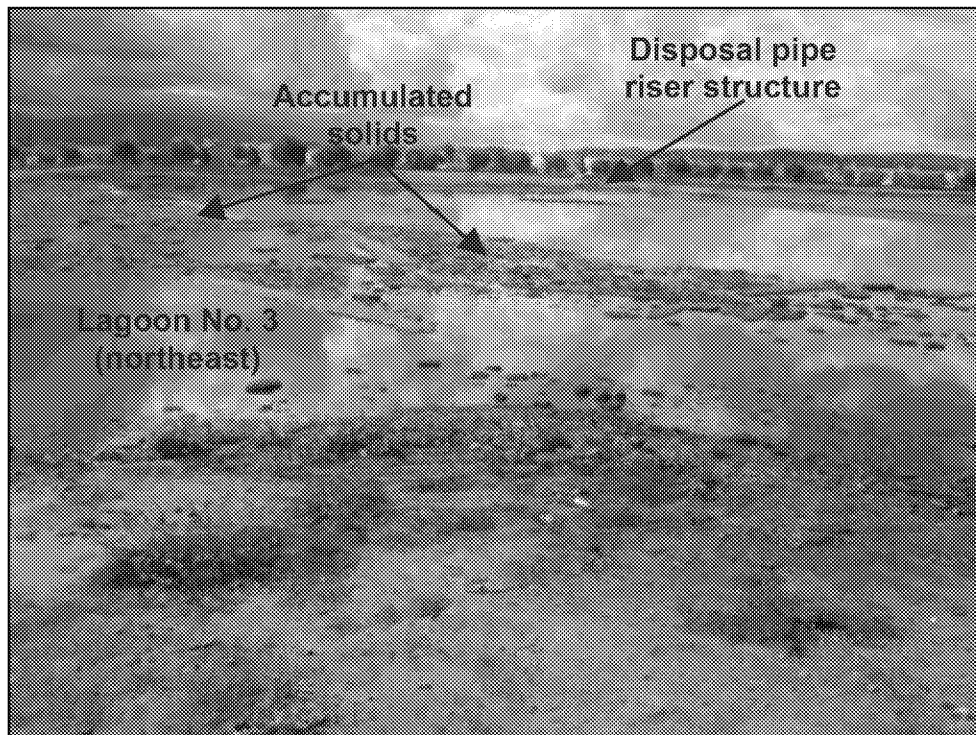
1. Depth markers were not installed in lagoon No. 1, located in the south-central portion of the Facility, or in the northern sections of lagoon Nos. 2 and 3 located in the eastern portion of the Facility, as required by Permit Attachment B - Monitoring and Reporting Program, Section I.B.1 (refer to Photos 16 through 19). Lagoon Nos. 2 and 3 had been divided in half by an east/west earthen berm; therefore, dividing lagoon Nos. 2 and 3 into four (4) separate lagoons (refer to Photos 6, 11, 12, and 13). This is a recurring issue identified in a previous inspection conducted on May 7, 2012.

1. The inspector observed, during the inspection, that depth markers had not been not installed in lagoon No. 1 located in the southern portion of the Facility, and in the northeast and northwest lagoons (north sides of lagoon Nos. 2 and 3) located in the eastern portion of the Facility as required by the Permit (refer to Photos 16 through 19). It should be noted that the EWMP and Site Plan only identify three (3) lagoons; however, five (5) lagoons were identified at the Facility. Only the southern portions of lagoon Nos. 2 and 3 contained depth markers. An east/west earthen berm had been constructed dividing lagoon Nos. 2 and 3 into four (4) separate lagoons (refer to Photos 6, 11, 12, and 13). Due to the separation berm, the northern sides of lagoon Nos. 2 and 3 had become separate lagoons, and did not contain depth markers. Permit Attachment B - Monitoring and Reporting Program, Section I.B.1 states that "a marker shall be placed within each pond or impoundment to indicate the minimum capacity necessary to contain the runoff and direct precipitation of the 25-year, 24-hour rainfall event."

Photograph 16. View facing south of the northeast portion of lagoon No. 3. Note the accumulated solids in the lagoon. Also note the lagoon did not contain a depth marker.

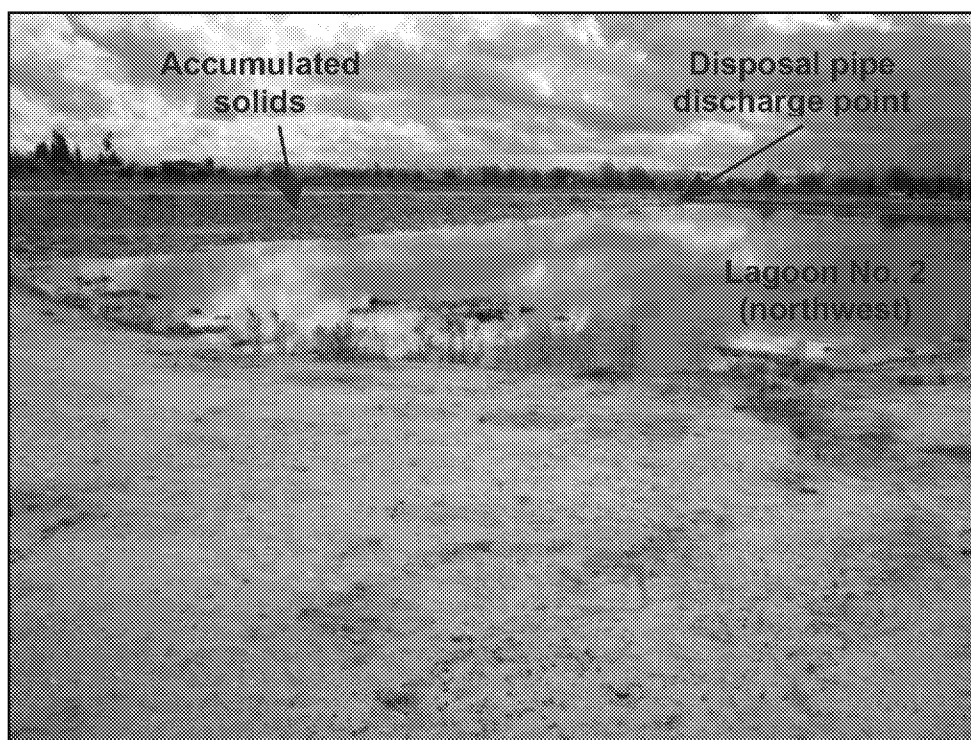
Photograph 17. View facing southeast of the northwest portion of lagoon No. 2. Note the accumulated solids in the lagoon. Also note the lagoon did not contain a depth marker.

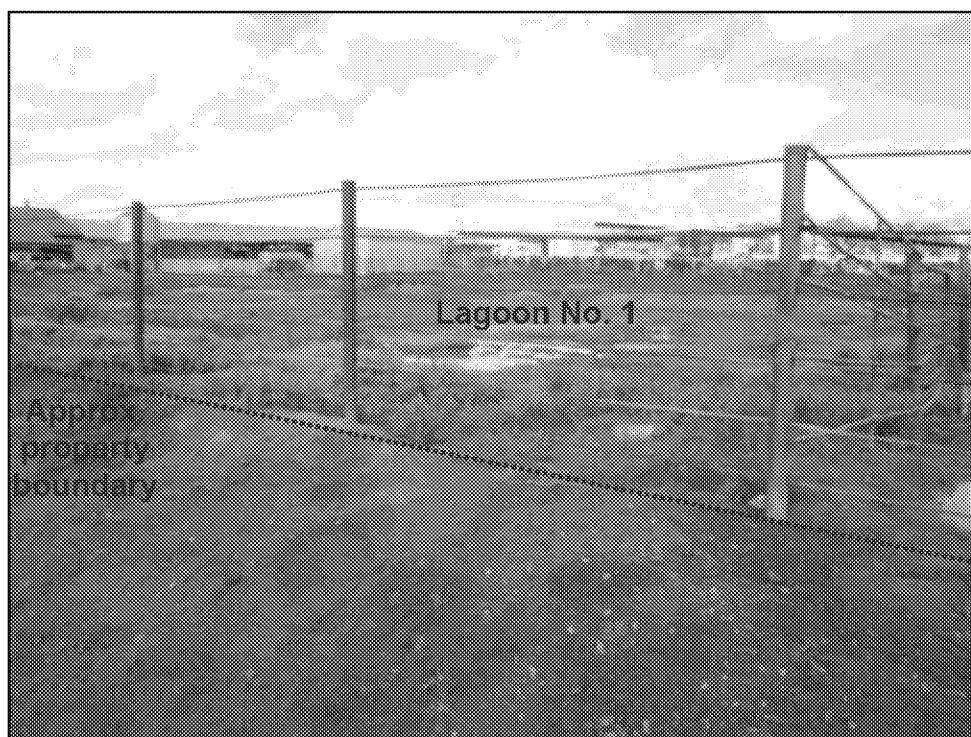
Photograph 18. View facing northwest of lagoon No. 1. Note the lagoon receives storm water runoff from corral Nos. 3 through 7. The lagoon did not contain a depth marker.

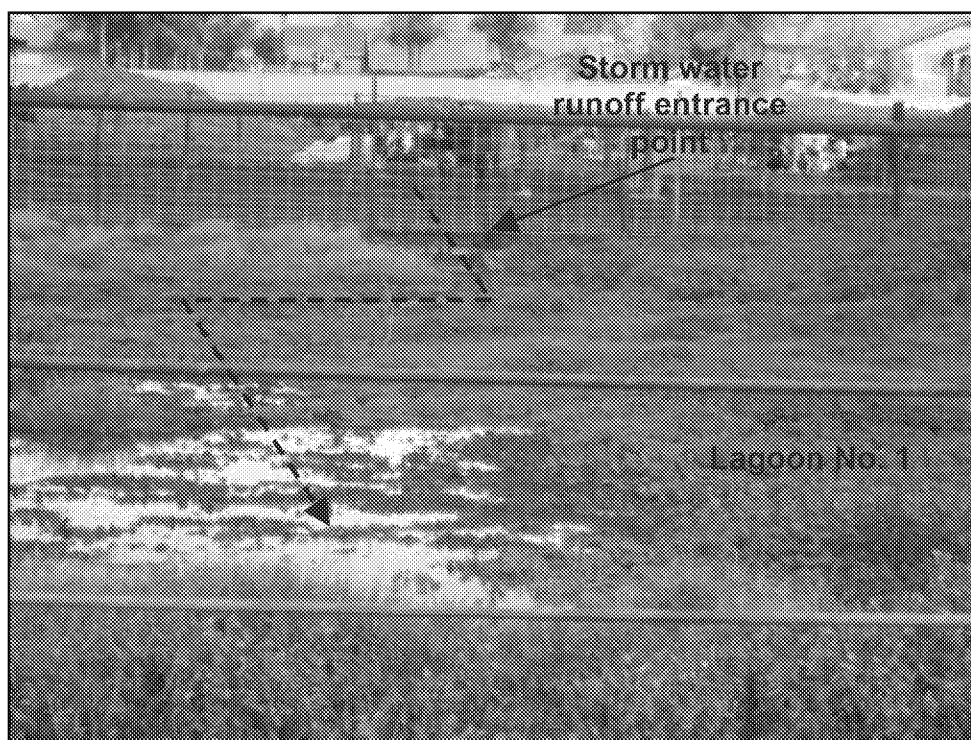
Photograph 19. View facing north of the storm water runoff entrance point from the eastern corrals into the north side of lagoon No. 1. Note the lagoon did not contain a depth marker.

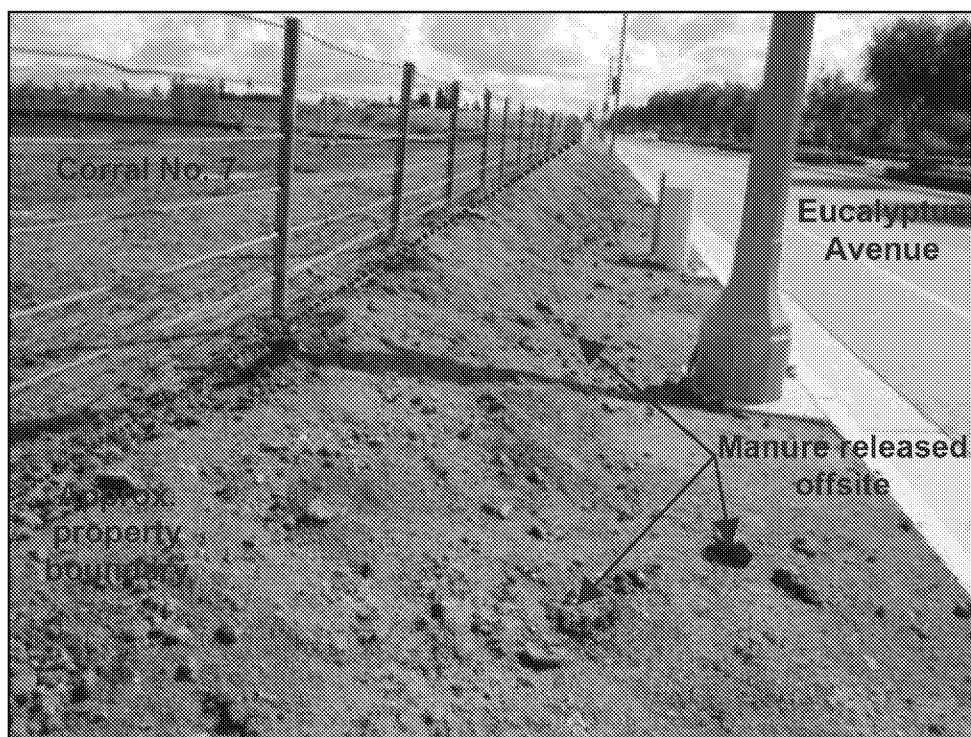
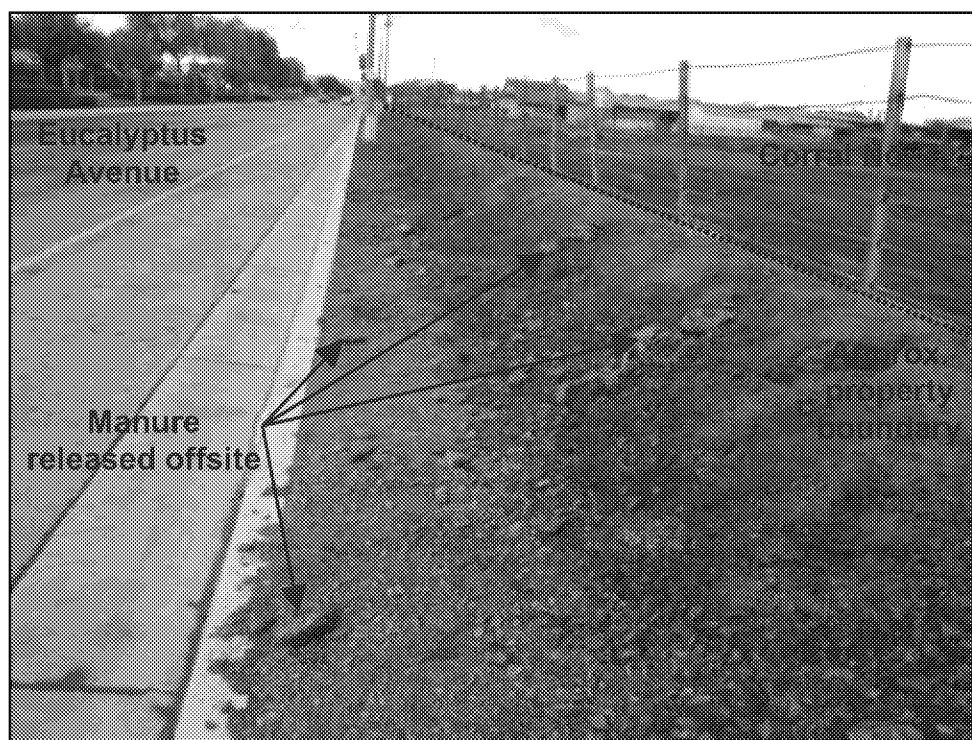
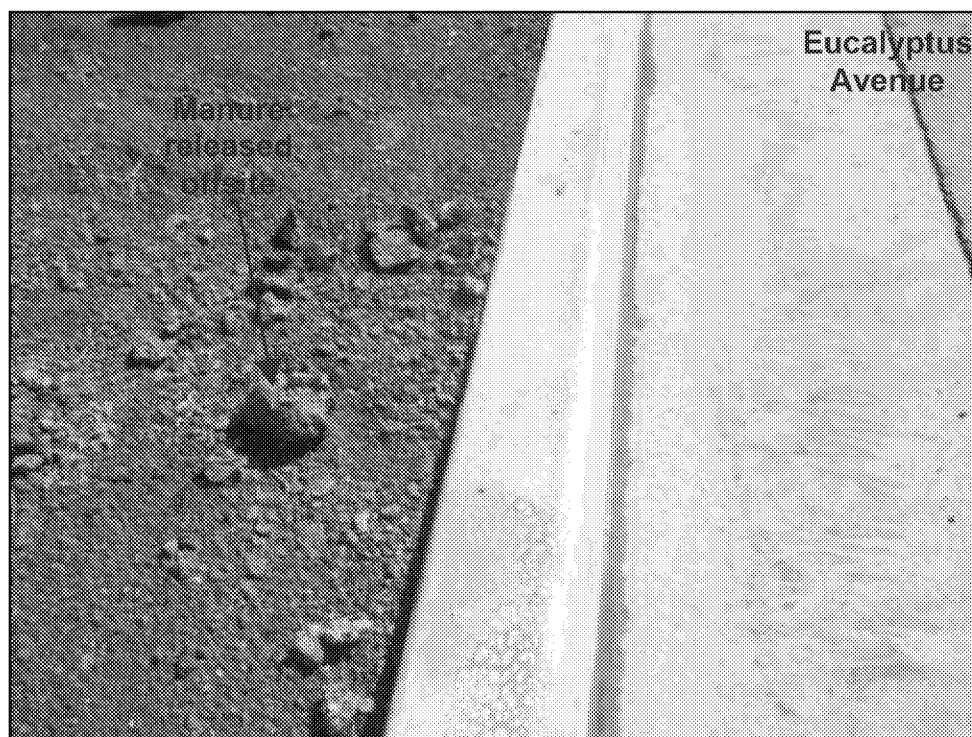
4. A release of manure offsite to the south onto the Eucalyptus Avenue right-of-way, was observed by the inspector, at the time of the inspection (refer to Photos 20, 21, and 22). A release of manure offsite to land and property not owned or controlled by the Discharger is prohibited by Discharge Prohibitions IV.A-B of the Permit.

1. The inspector observed, during the inspection, a release of manure offsite to the south from corral No. 7 onto the Eucalyptus Avenue right-of-way (refer to Photos 20, 21, and 22). The inspector did not receive any information regarding the offsite release of manure from the Facility representatives. Discharge Prohibition IV.B of the Permit states "disposal of manure to land is prohibited." In addition, Effluent Limitations and Discharge Specification V.1.a of the Permit specifies that pollutants may be discharged from the Facility if "the production area is designed, constructed, operated, and maintained to contain all manure, litter, and process wastewater including the runoff and the direct precipitation from a 25-year, 24-hour rainfall event."

Photograph 20. View facing east of a release of manure offsite to the south from corral No. 7 onto the Eucalyptus Avenue right-of-way.

Photograph 21. View facing west of a release of manure offsite to the south from corral No. 7 onto the Eucalyptus Avenue right-of-way.

Photograph 22. Close-up view of a release of manure offsite to the south from corral No. 7 onto the Eucalyptus Avenue right-of-way.

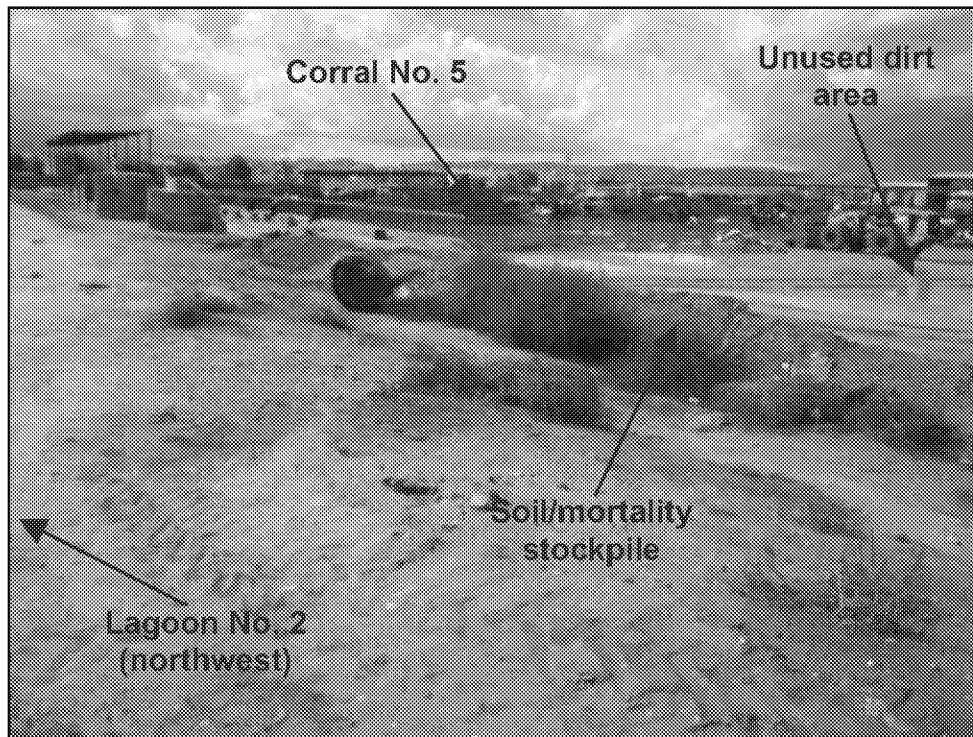
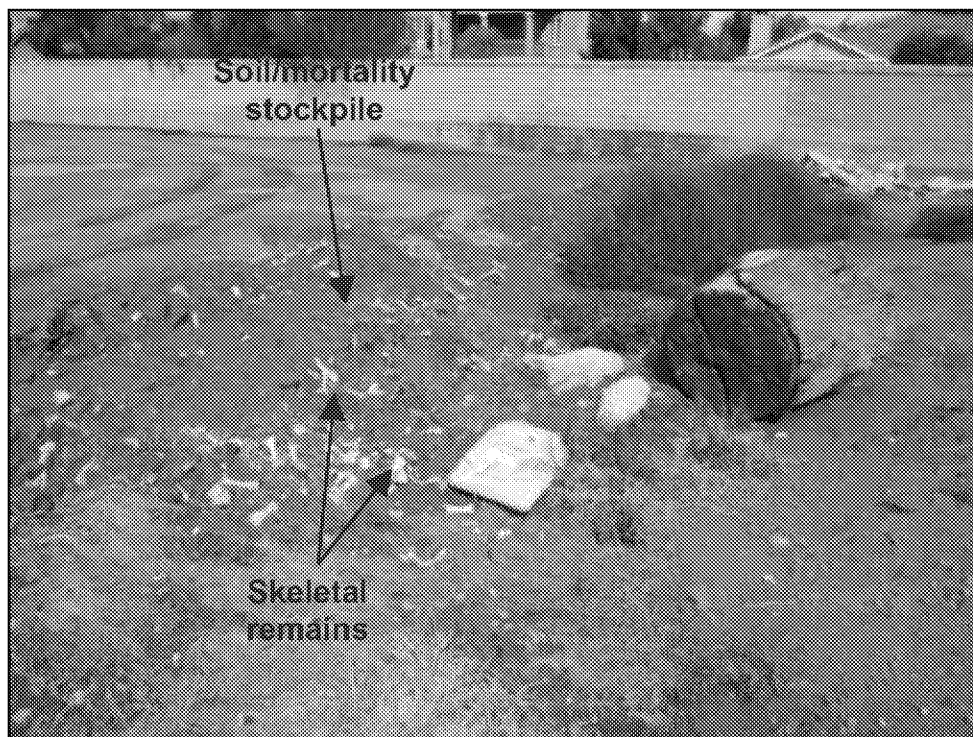
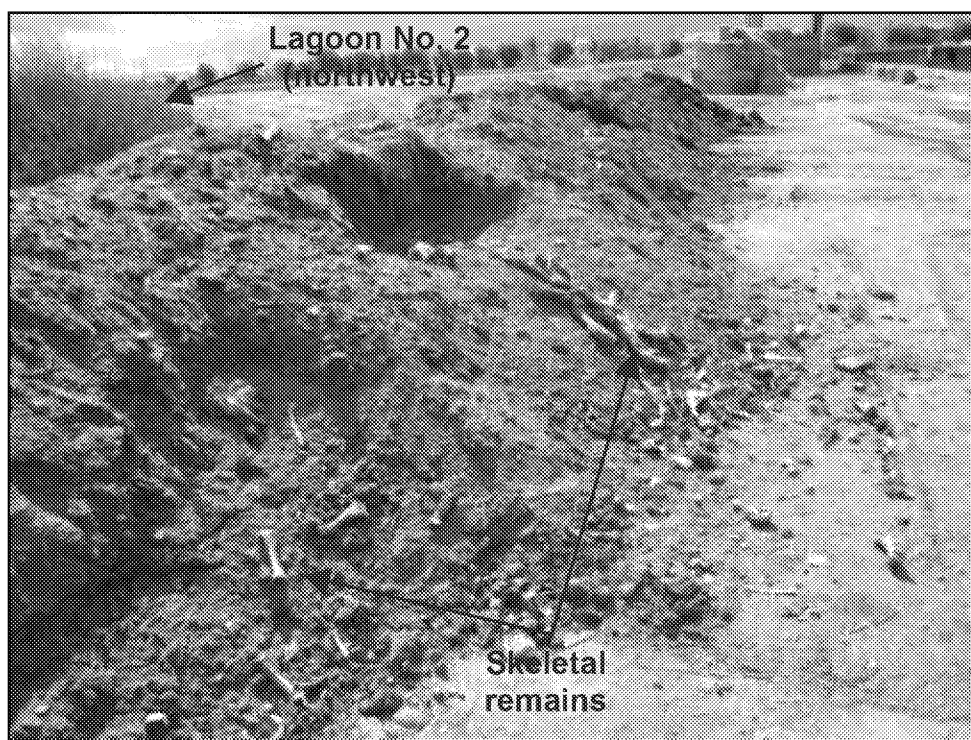
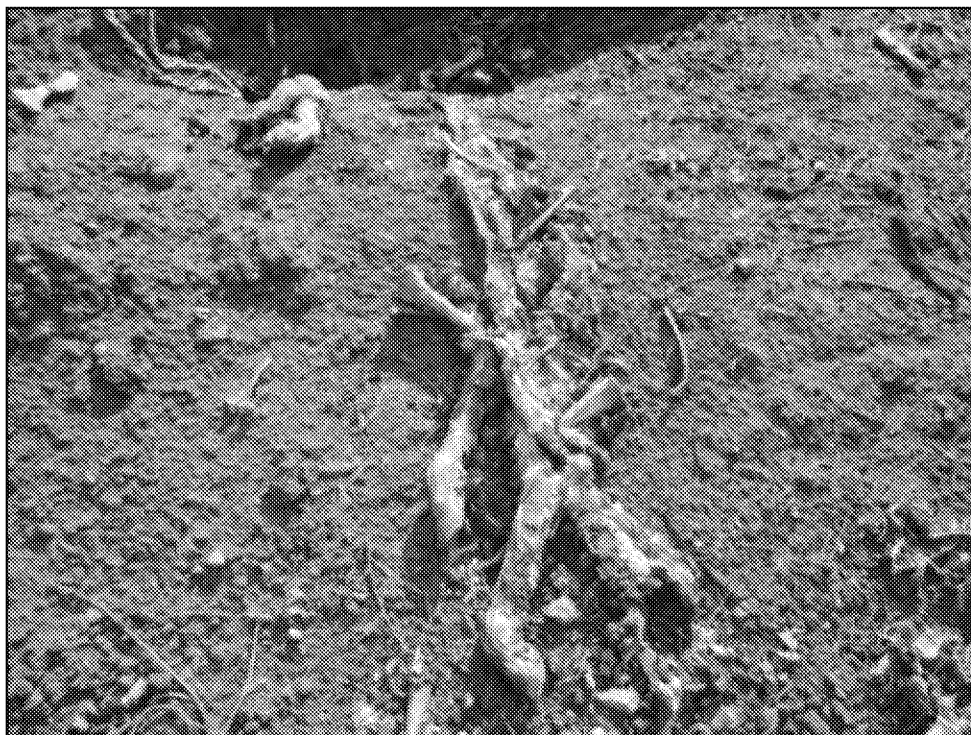
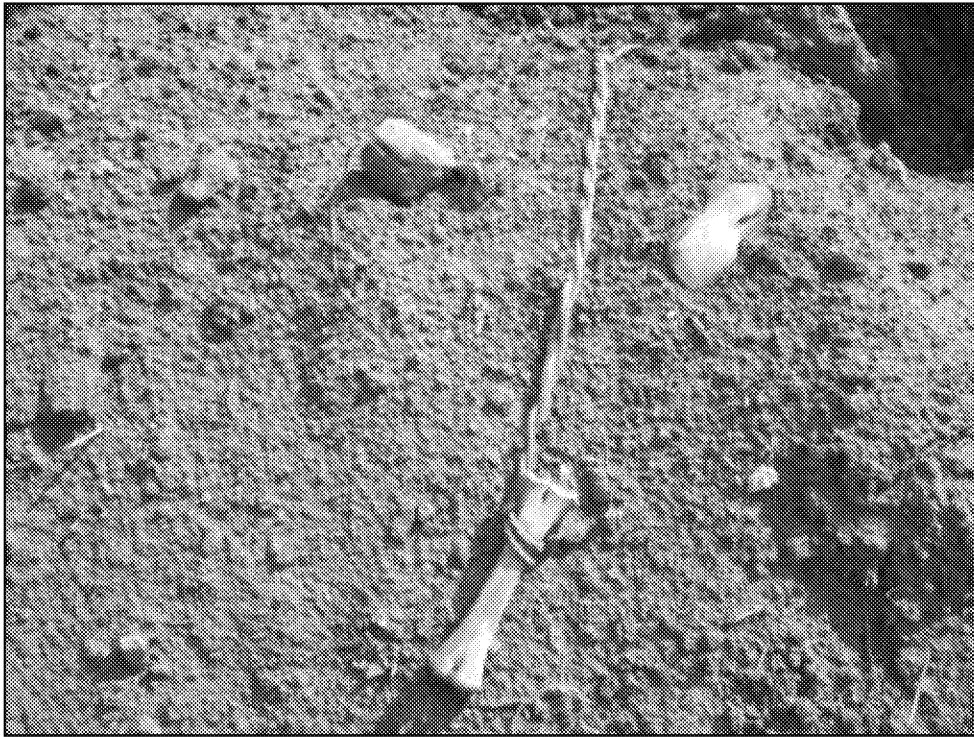
- A stockpile of skeletal remains (i.e., livestock mortalities) was observed on the northwest side of lagoon No. 2 (refer to Photos 23 through 27)
- Accumulated manure solids were observed in lagoons Nos. 2 and 3 (refer to Photos 10, 11, 16, and 17)

2. The inspector observed, during the inspection, a soil stockpile containing skeletal remains (i.e., livestock mortalities) on the west side of the northwest lagoon (north side of lagoon No. 2) in the unused dirt area (refer to Photos 23 through 27). The soil stockpile and skeletal remains appeared to be contained onsite; however, storm water runoff from the stockpile most likely would flow south through the eastern corrals and enter lagoon No. 1. Discharge Prohibition IV.F of the Permit states "the disposal of any mortality in any process wastewater system is prohibited. Mortalities shall be handled in such a way as to prevent the discharge of pollutants to waters of the state."

Photograph 23. View facing southwest of a soil stockpile containing livestock skeletal remains in the unused dirt area in the north-central portion of the Facility, adjacent to lagoon No. 2.

Photograph 24. View facing northwest of skeletal remains in the soil stockpile shown in Photograph 23.

Photograph 25. View facing southeast of skeletal remains in the soil stockpile shown in Photographs 23 and 24.

Photograph 26. Close-up view of skeletal remains shown in Photograph 25.

Photograph 27. Close-up view of skeletal remains in the soil stockpile, shown in Photographs 23 through 26.
